Style Inspections, Inc.
5944 Danbury Road
Tampa, Florida 33587
813-698-5588
gwinston@styleinsp.com

Client Name **Gerald Watson**

Inspection Date: 3/25/2002

Property: 5944 Danbury Road
Tampa, Florida 33587-0000

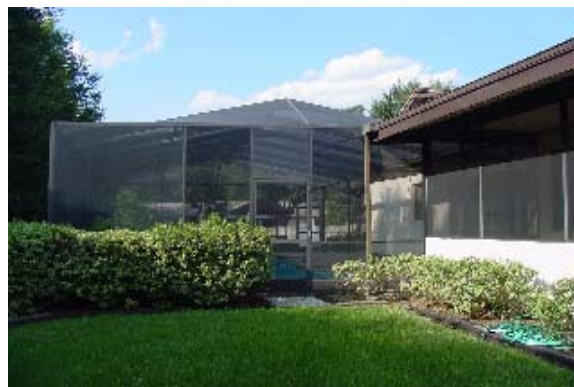
Screen panels above pool have areas of sun rot and need replacing. Vertical areas appear to have been replaced recently.

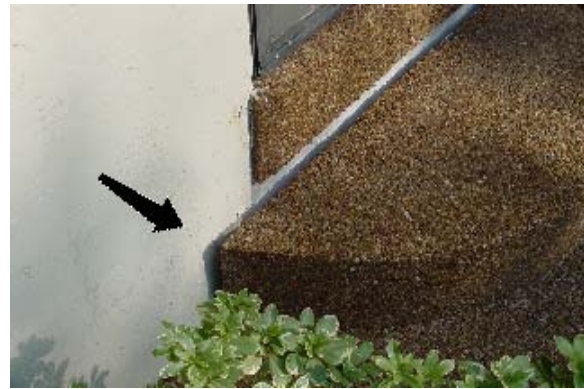
Stairs have settled away from foundation

Stairs have settled, pulling from wall. (See arrow) Stairs are repoured in one piece and will be difficult to shore in place. Consult a contractor for estimate.

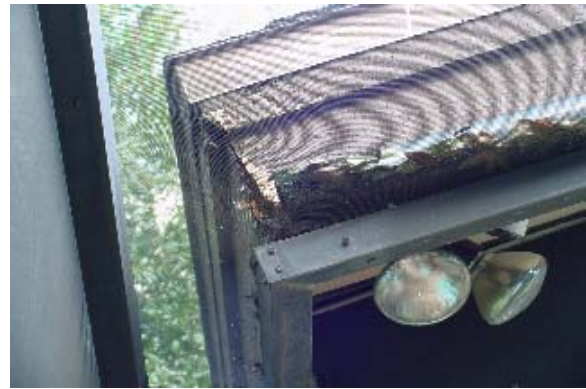
Fascia has rotten areas and needs replacing. The entire side has areas of rot. See a licensed contractor for estimate.

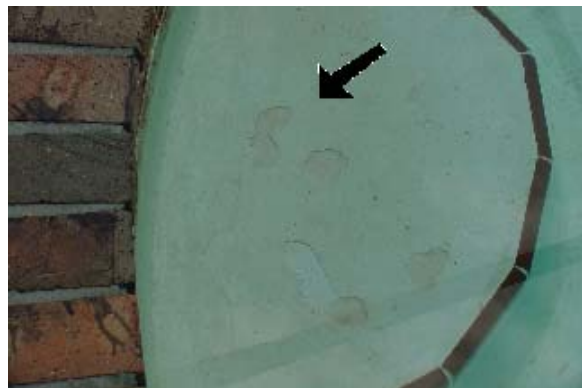
■ **Pool finish has missing patches**

The pool finish has areas that have broken out. This can develop leaks and allow algae to grow causing staining.
